**TECO's Responses OPC's Third Request
to Produce Documents, No. 11.**

**TAMPA ELECTRIC COMPANY
DOCKET NO. 20220001-EI
OPC'S THIRD REQUEST FOR
PRODUCTION OF DOCUMENTS
DOCUMENT NO. 11
BATES PAGES: 1-1472
FILED: AUGUST 10, 2022**

PK1 – Forced Major Outage High Potential
Date: 11/29/2021

Polk Power Station

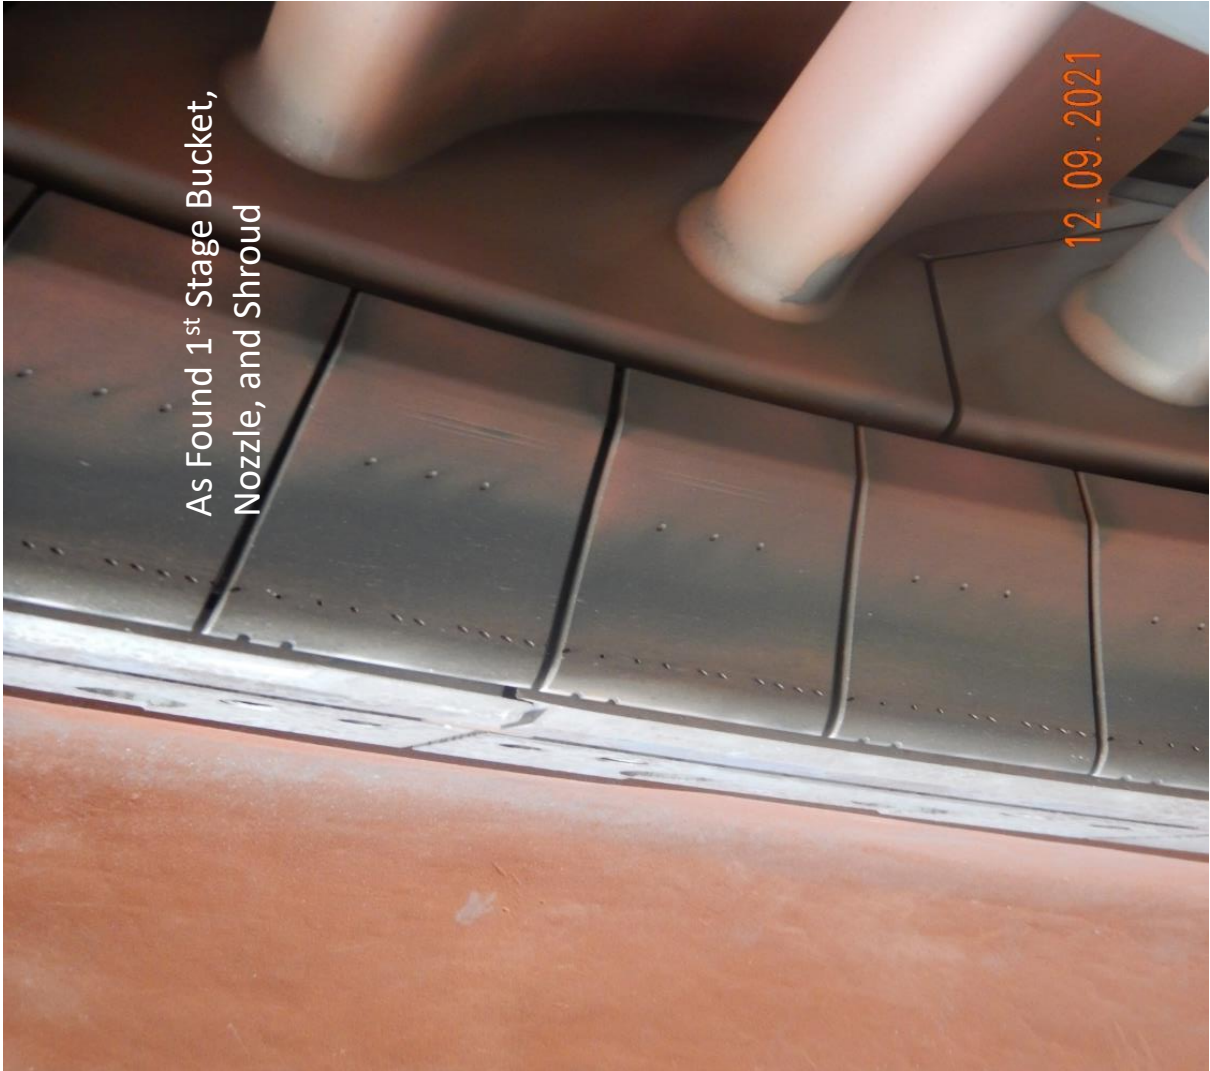
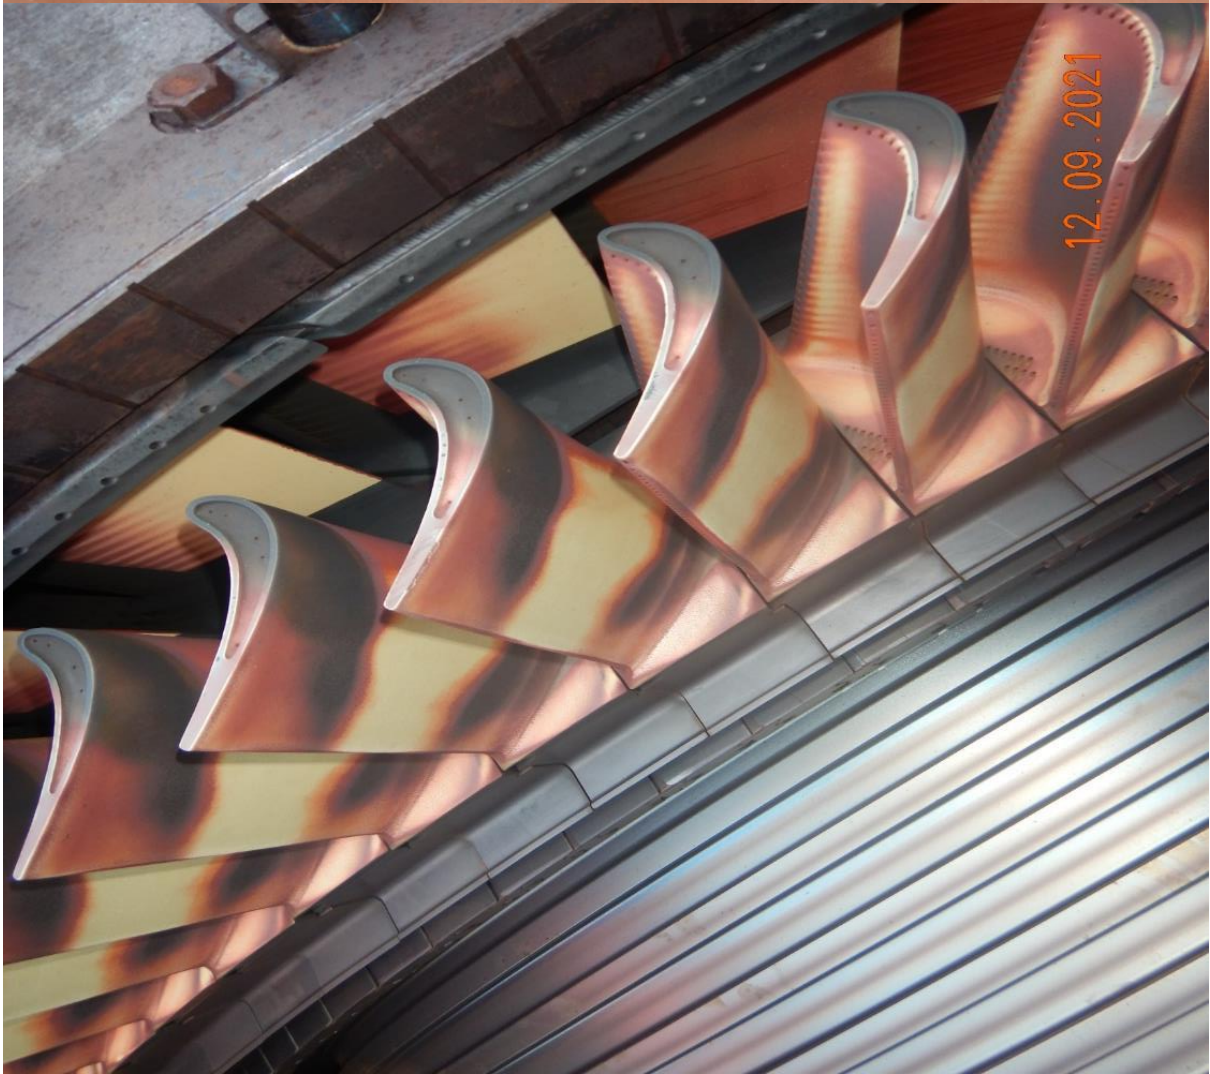
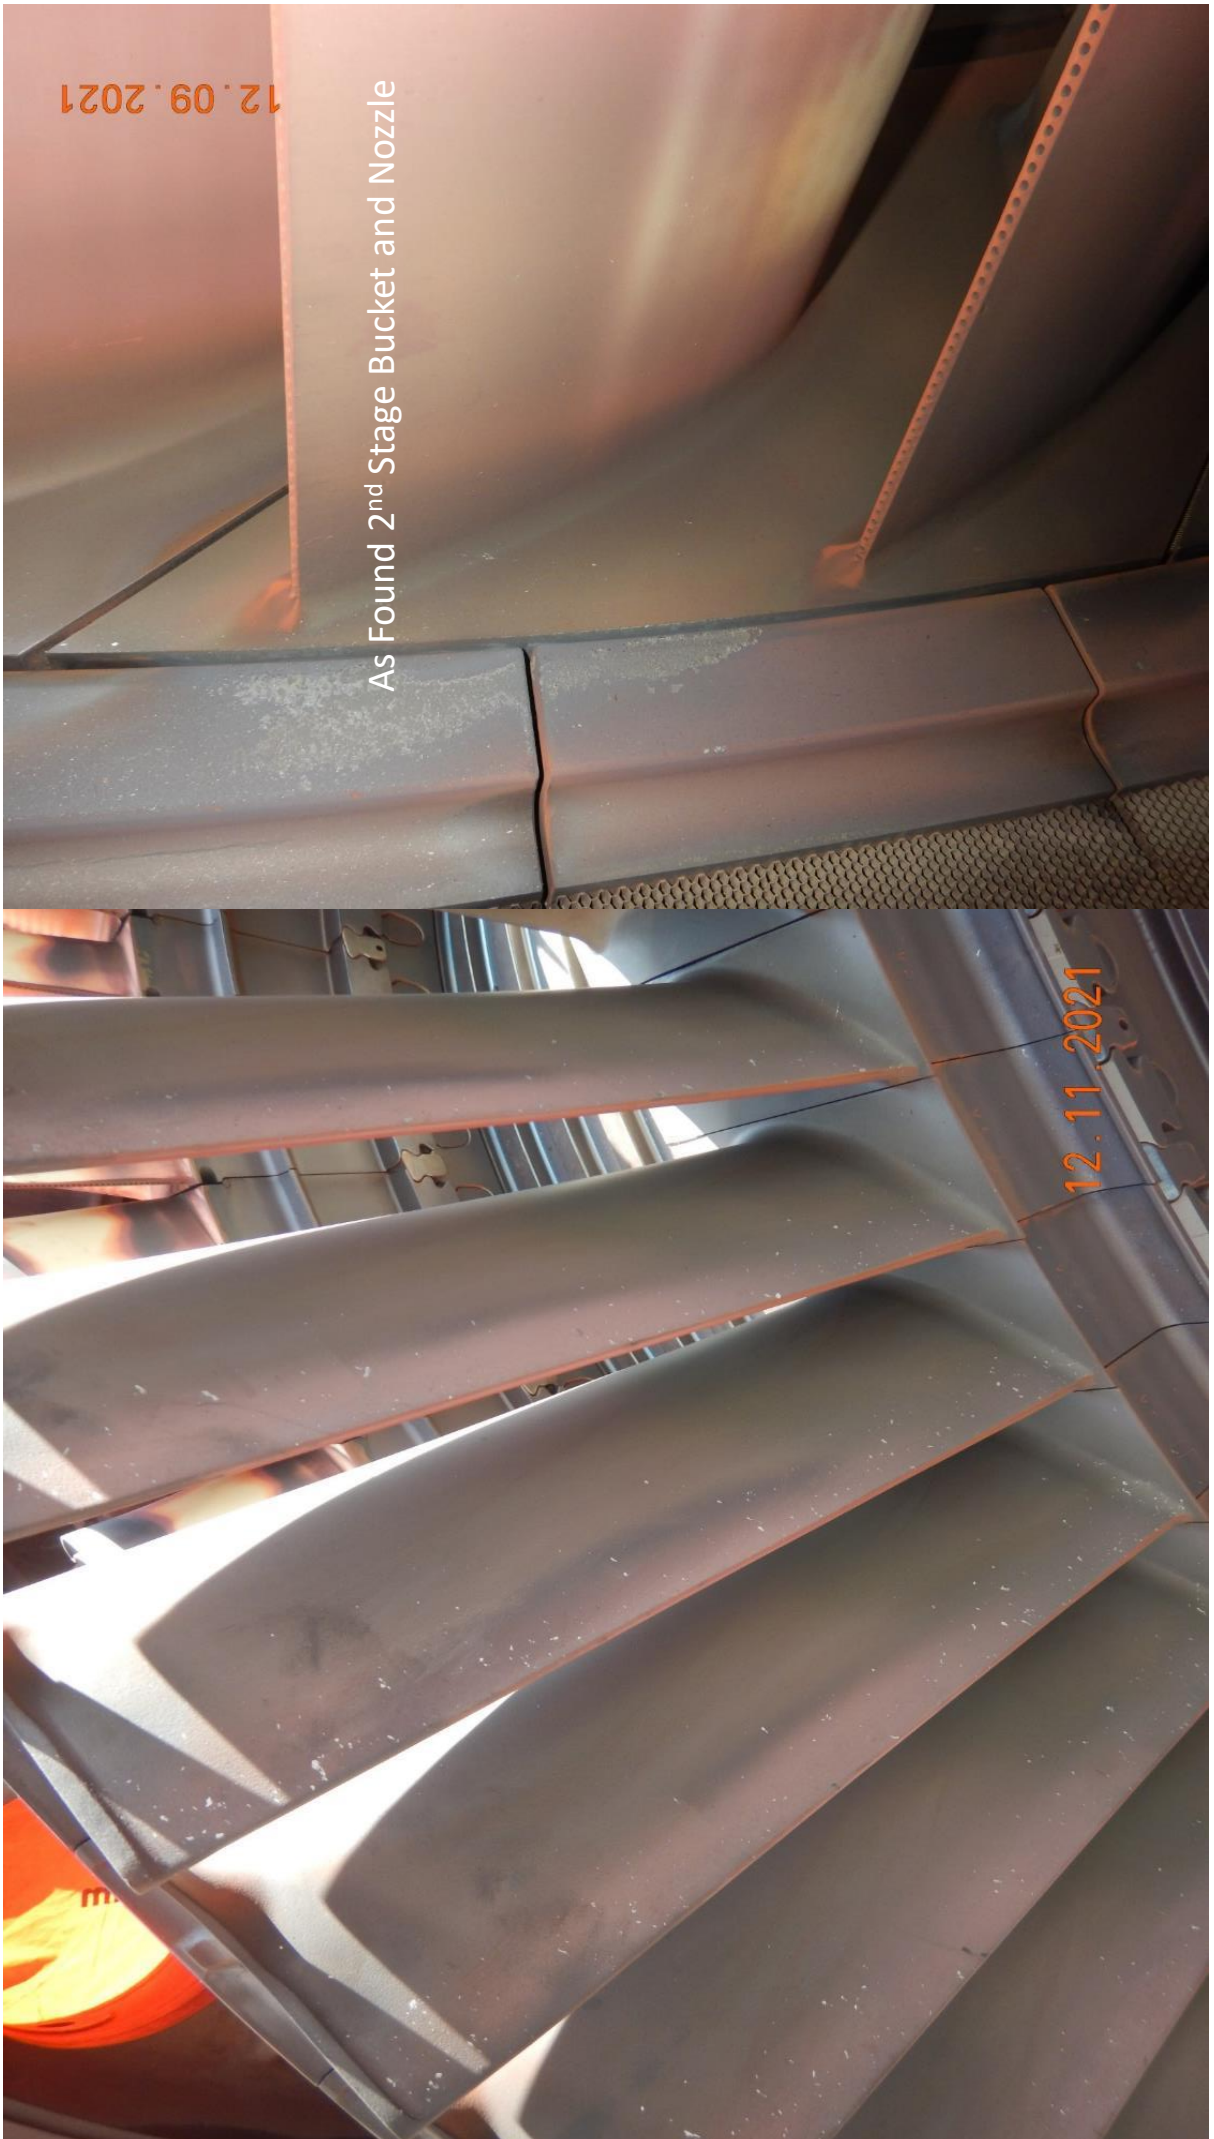
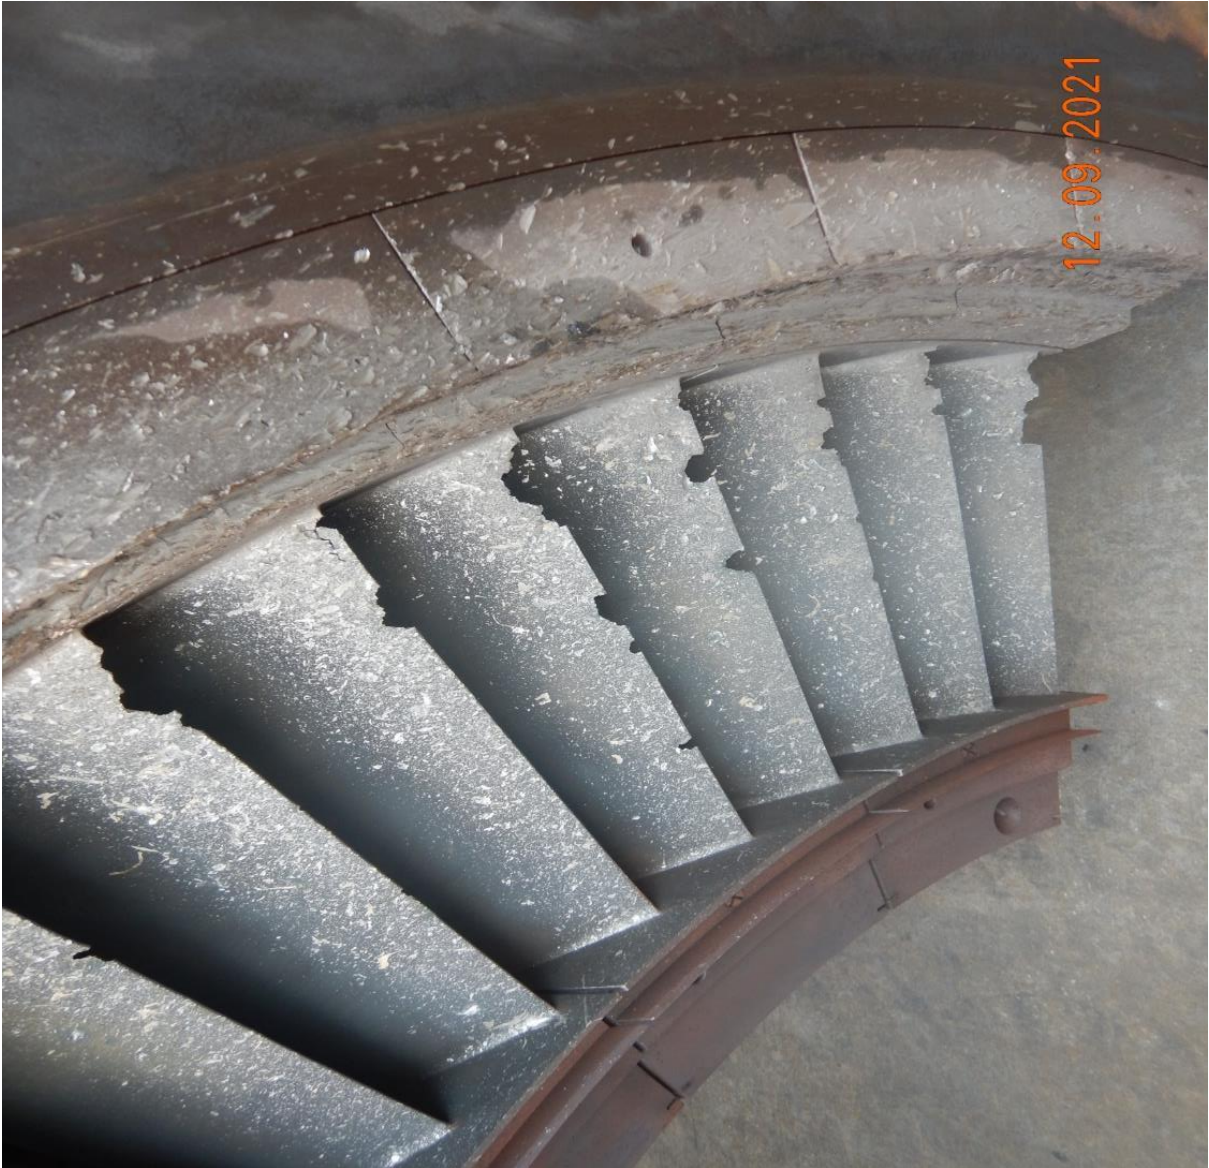
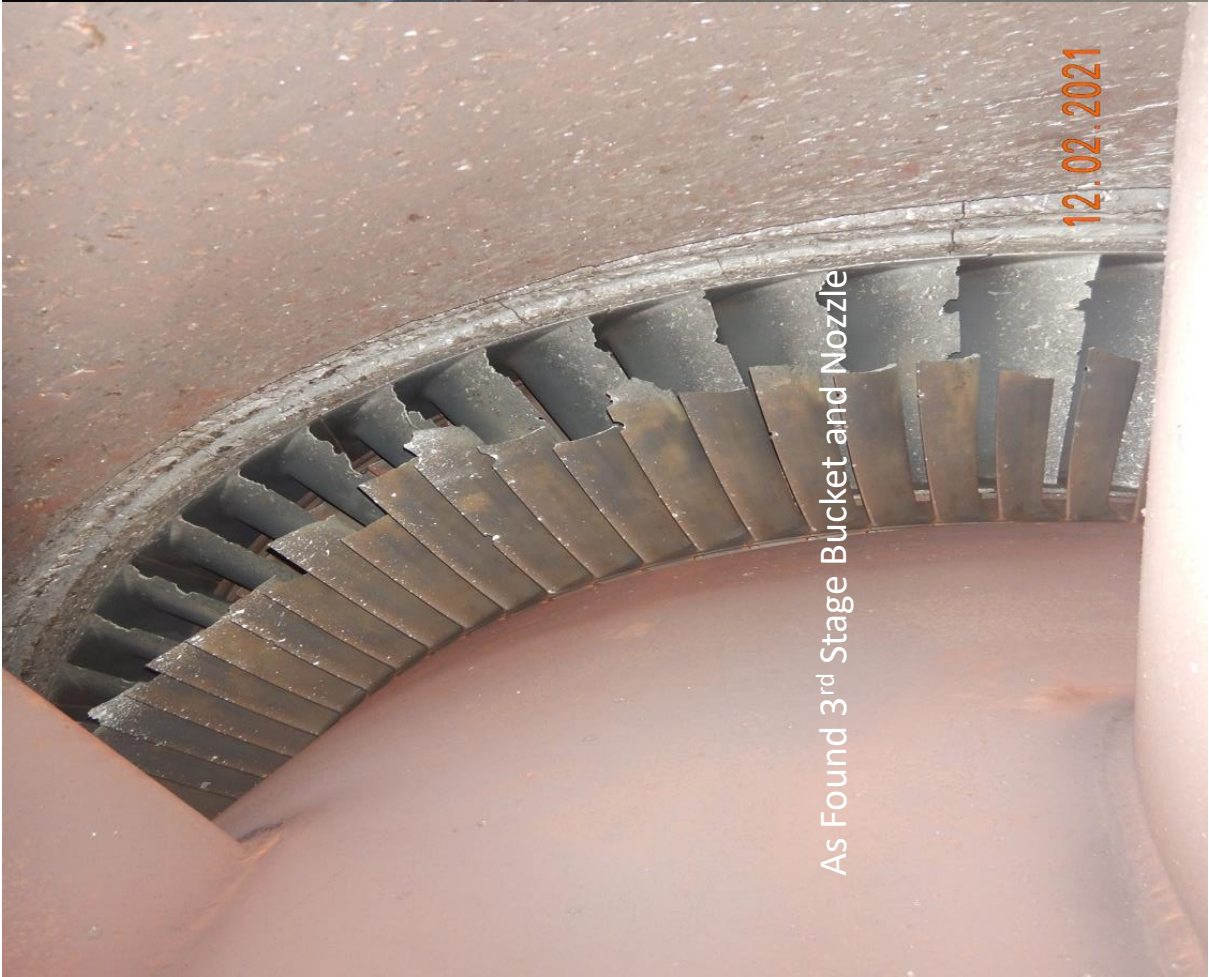
As Found 1st Stage Bucket and
Nozzle

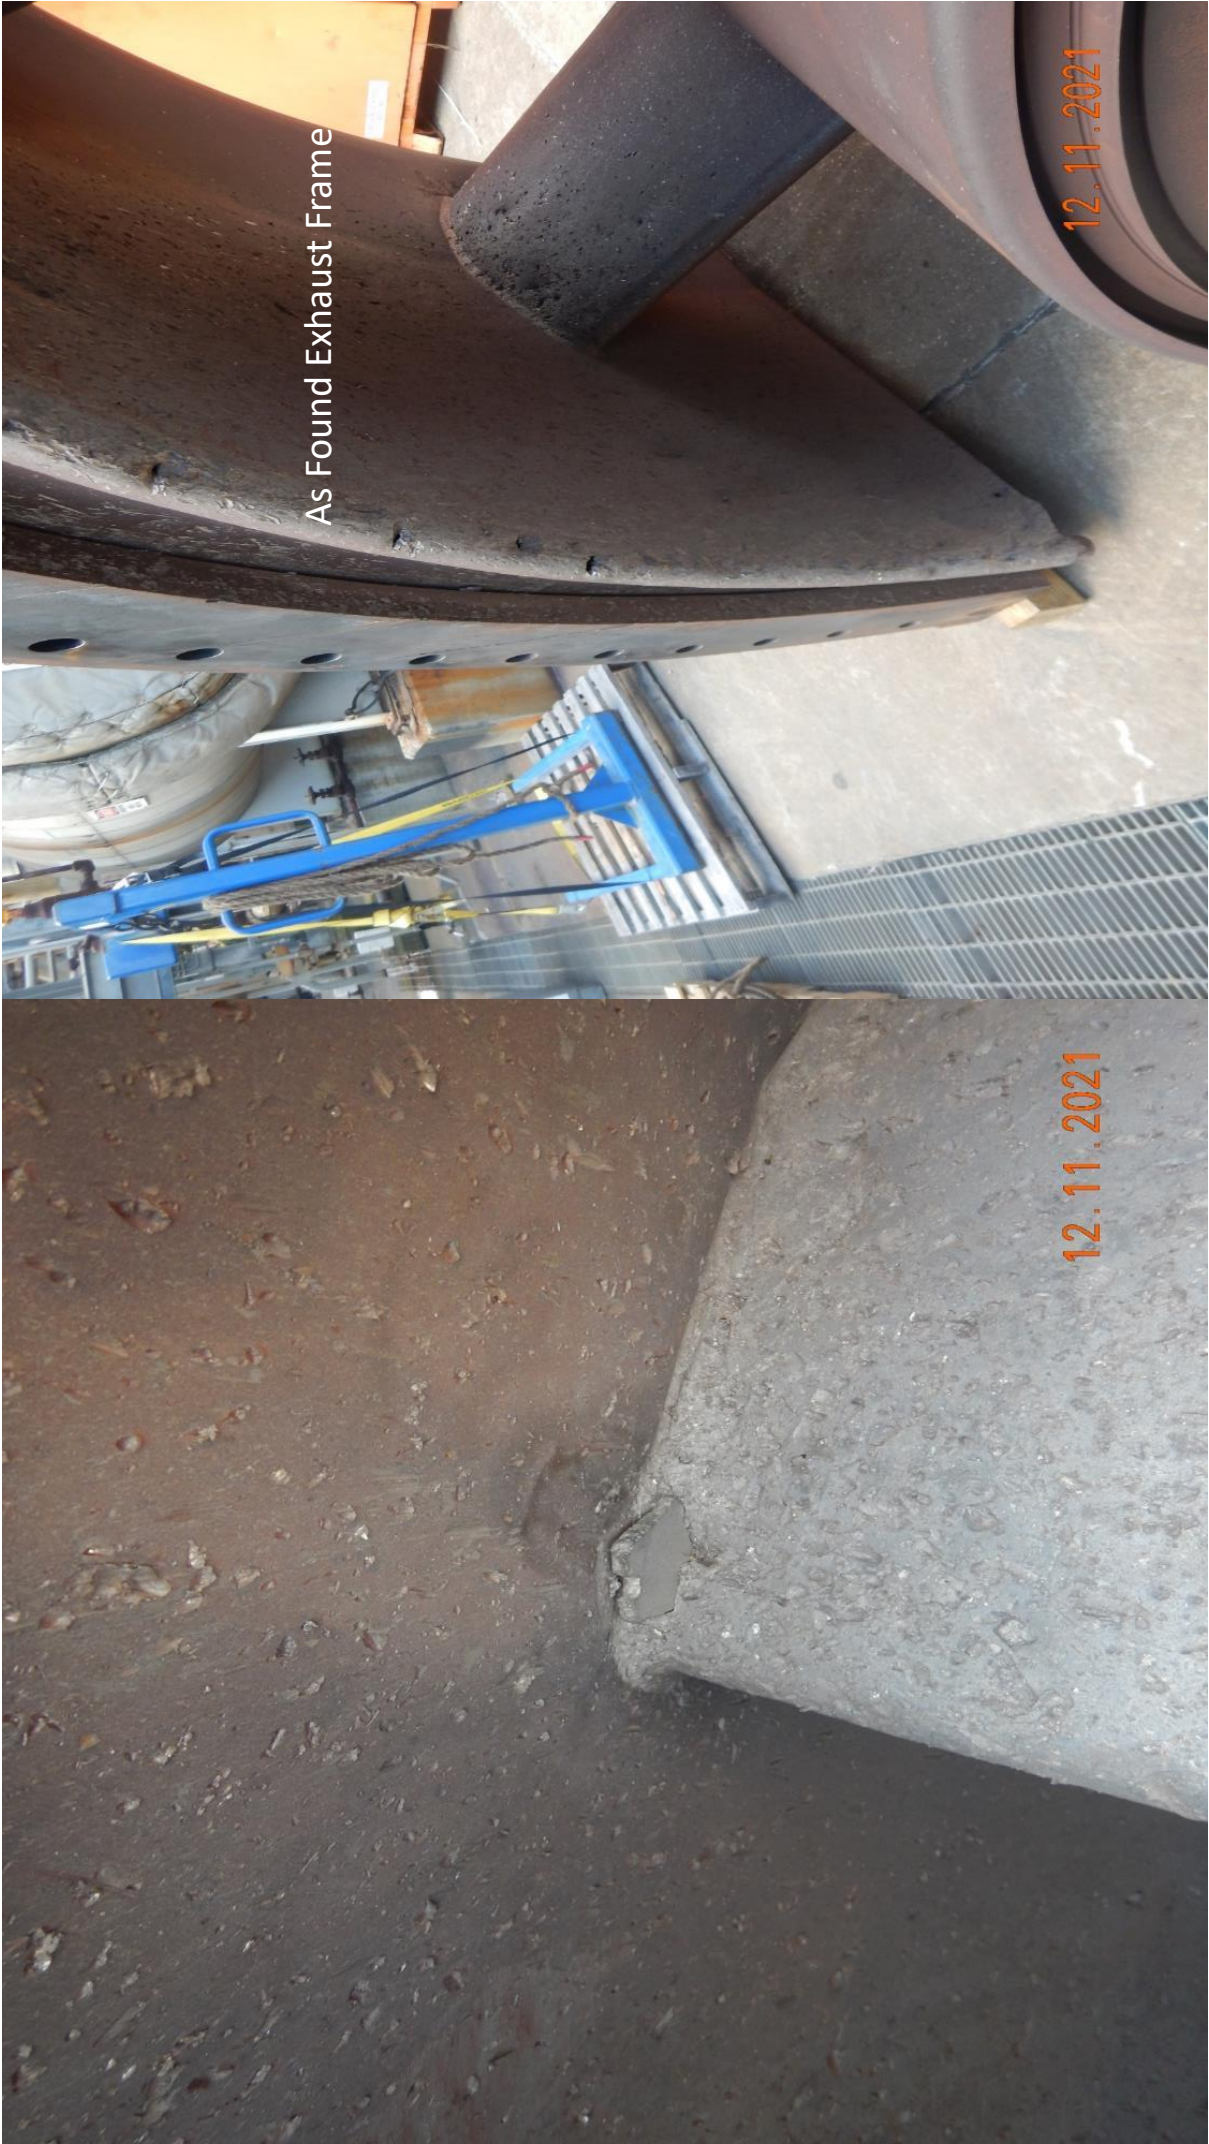
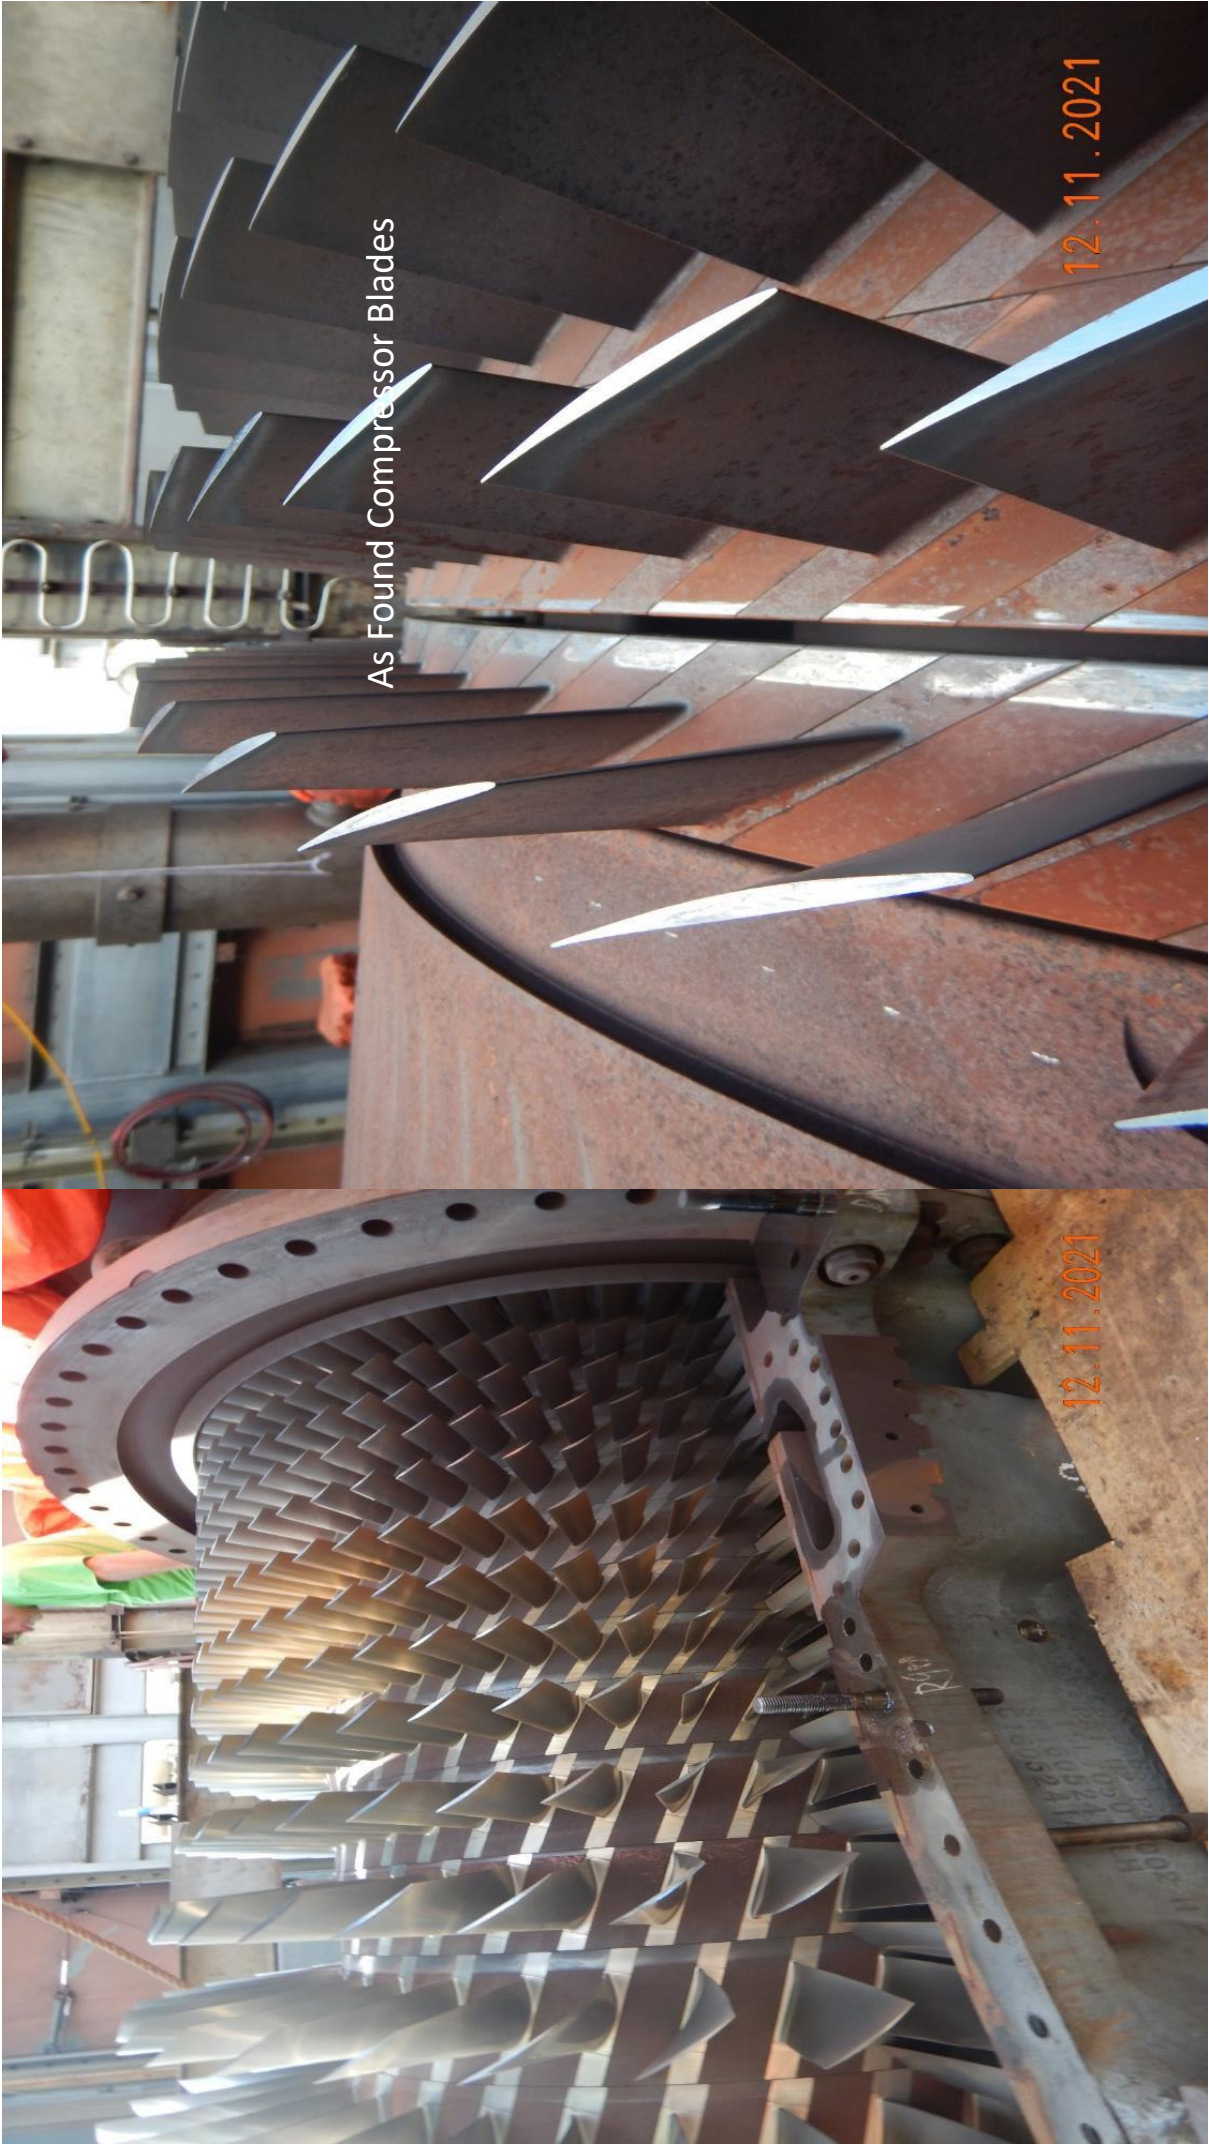
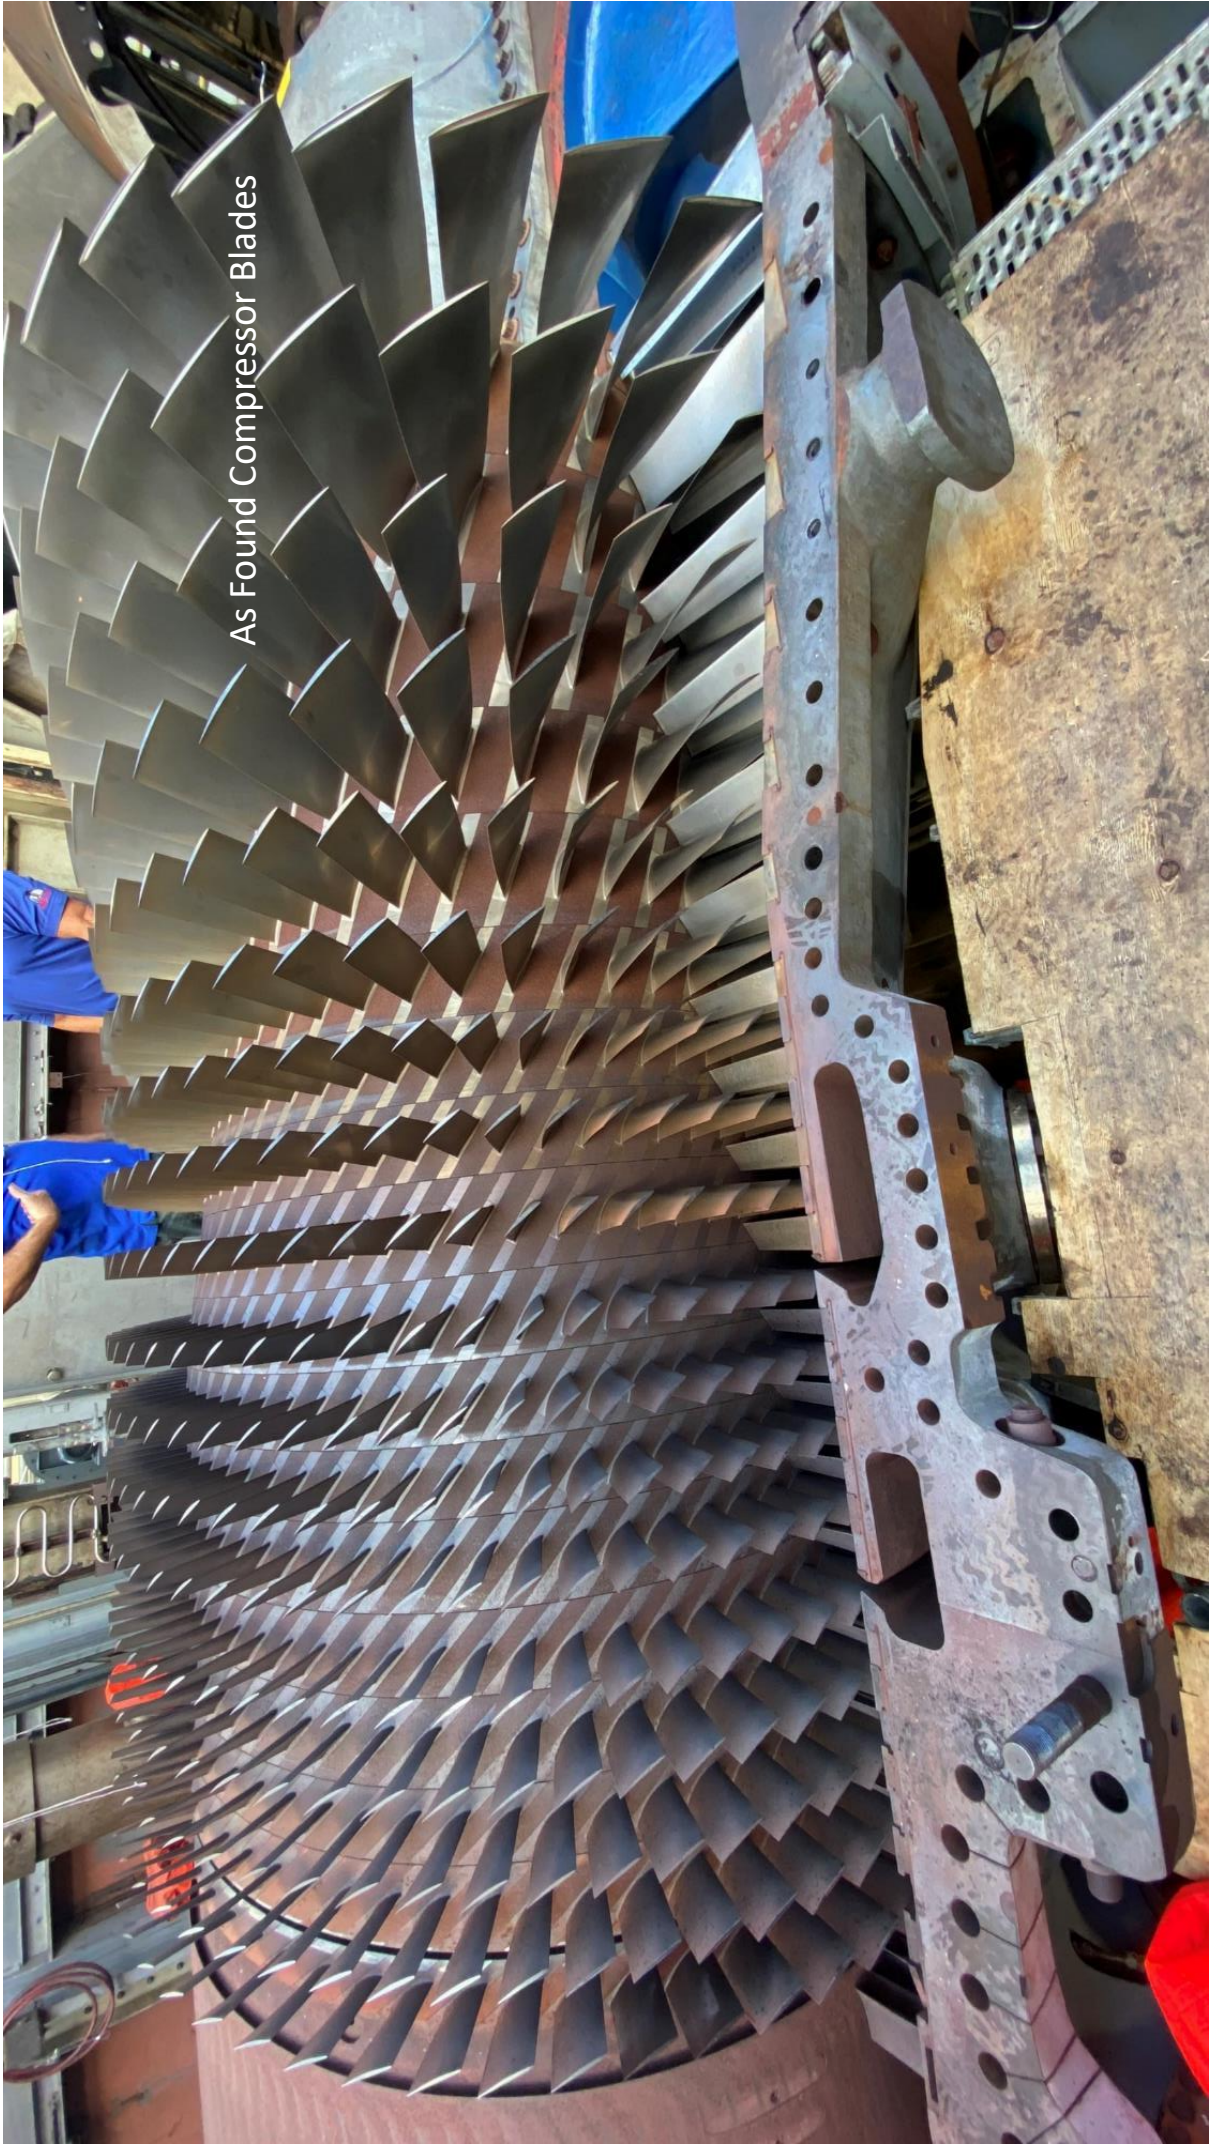
12.11.2021

As Found Turbine Blades

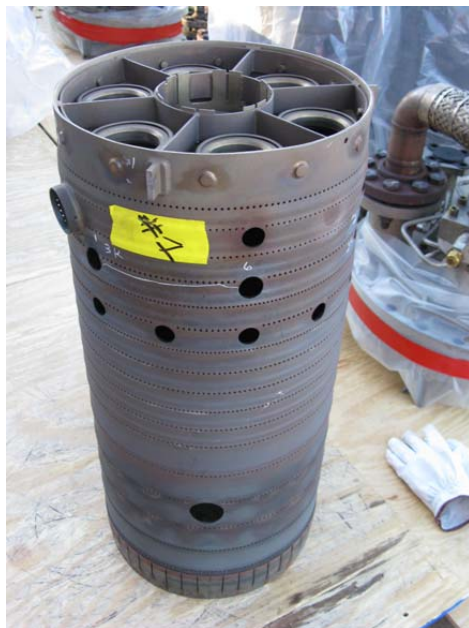
Liners As Found

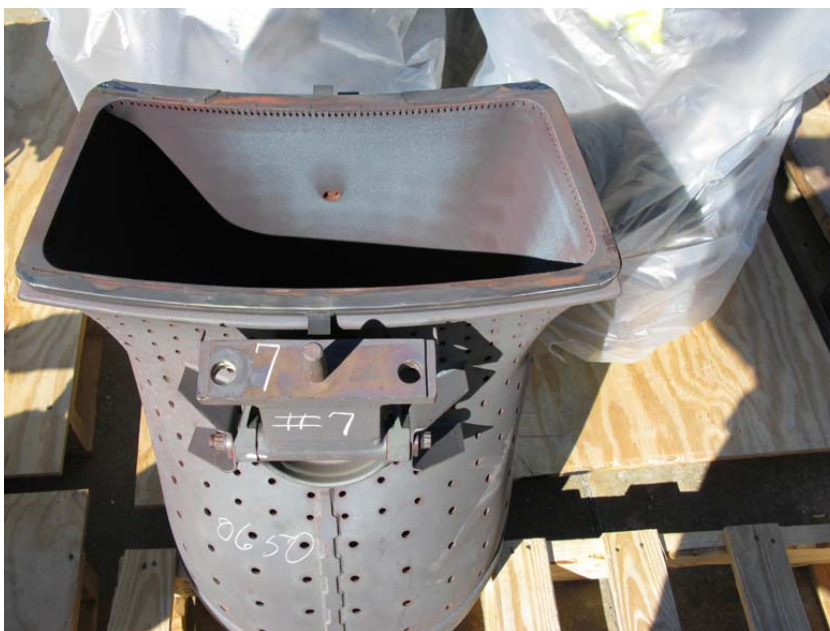
TP As Found Condition

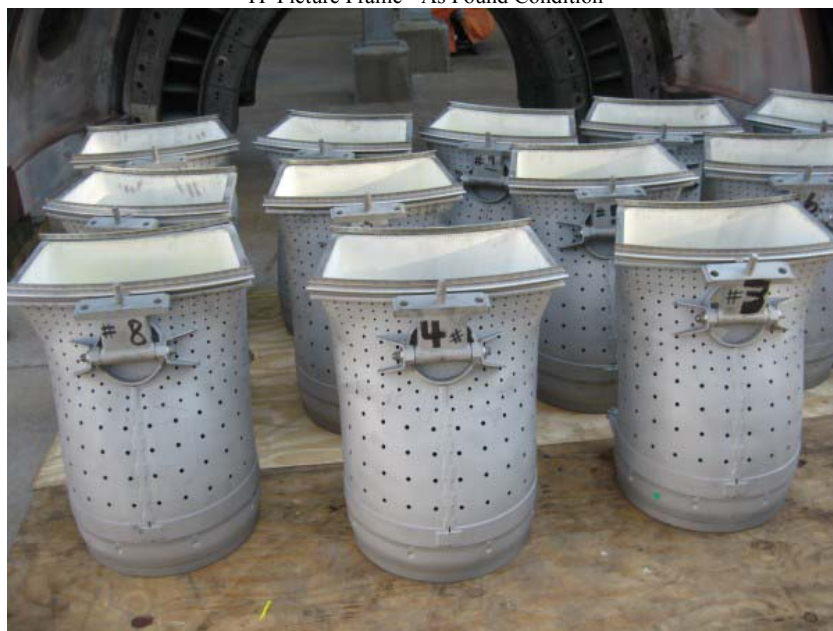
TP - New

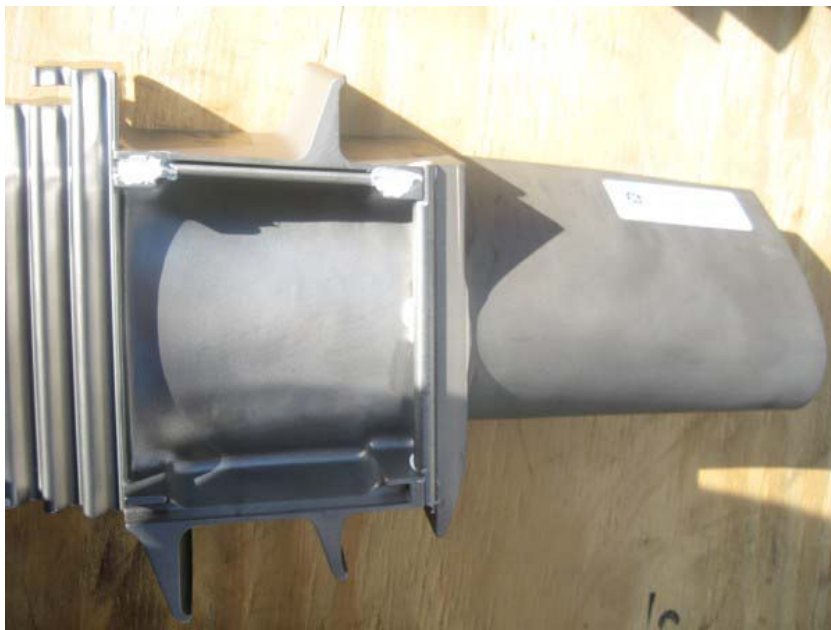
1st stage bucket - New

The first stage turbine buckets were removed and inspected by the GE representative. A GE Service Shop technician replaced them with customer spares. The spare set used was the style that utilized all 3 pins (1 platform and 2 seal pins).

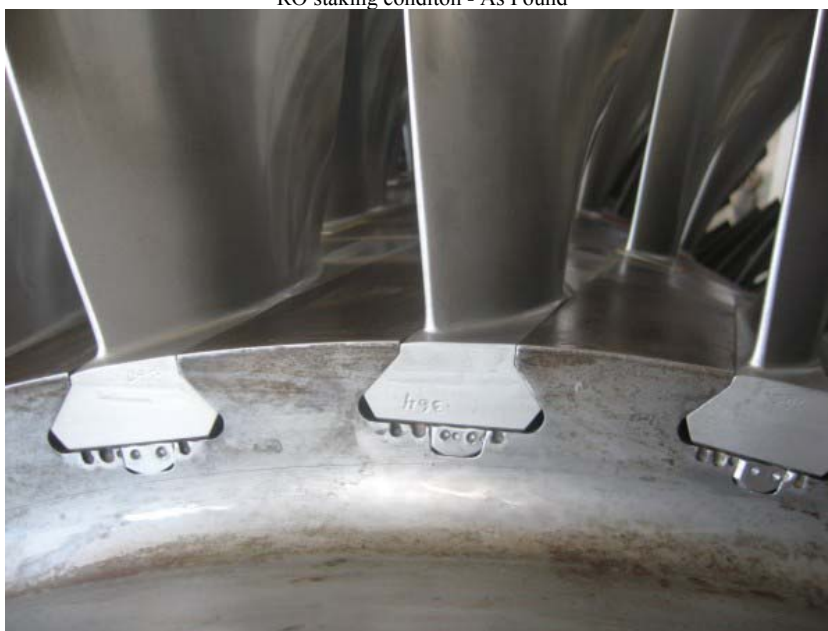
RO Biscuit Modification Completed in HSC

While in Houston Service Shop for repair, the compressor rotor was modified. Note that stages R0 and R3 were tipped to bring this compressor blade/wheel tip diameters to current AO standards. This CR forward stub shaft also received the R0 Biscuit Mod.

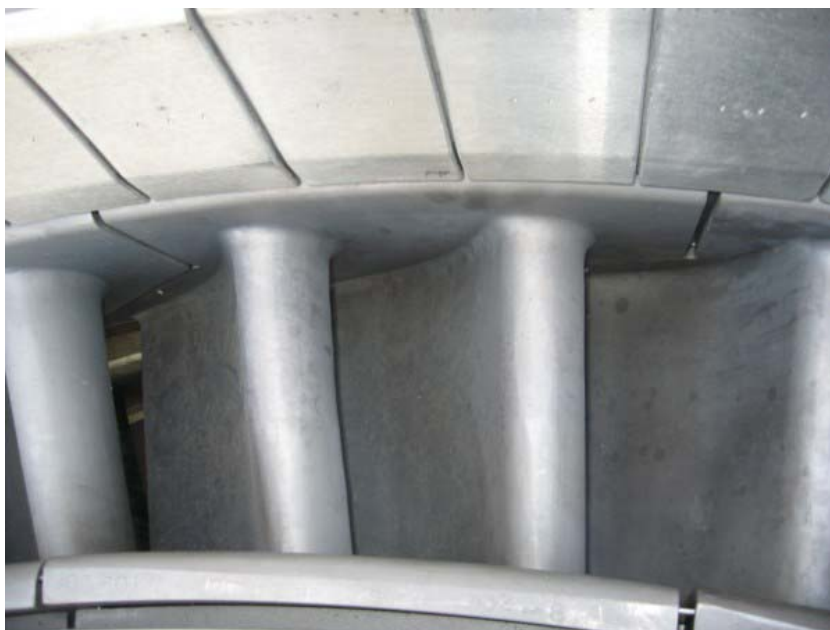
2nd Stage Nozzle - Typical Cracking

The 2nd stage nozzles were removed and GE visually inspected them for damage. They showed typical signs of wear for 24K hours. They were replaced with refurbished customer spares during reassembly.

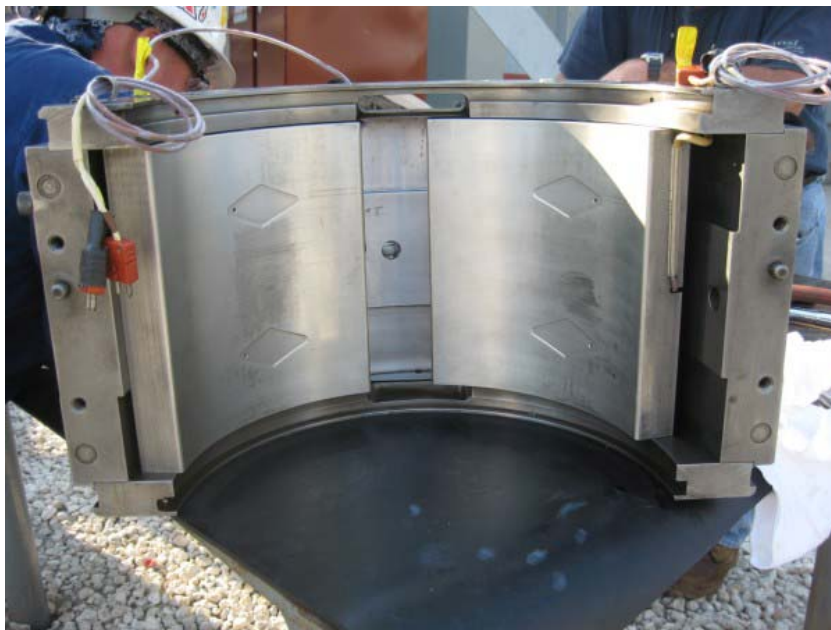
T2 bearing inspection

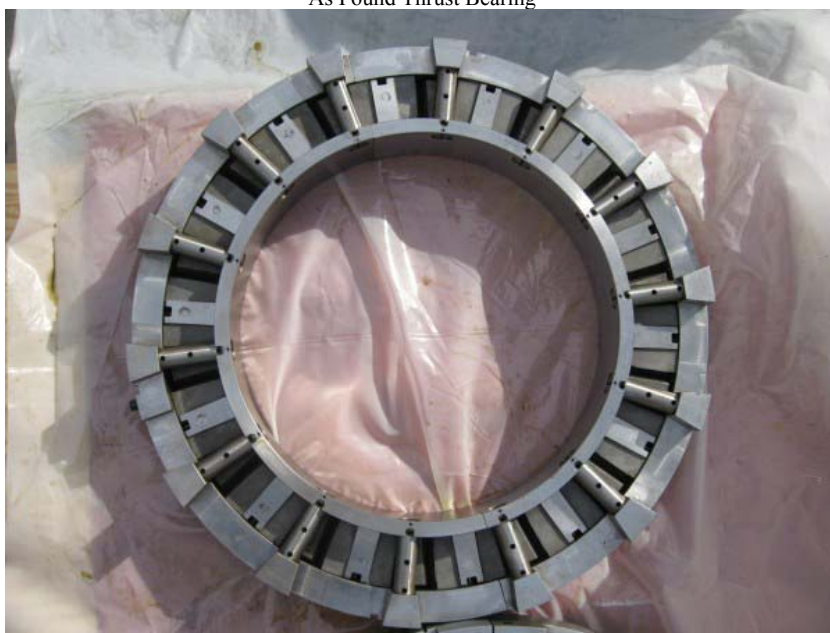
Aft Thrust Bearing Cage

Groove marks on each pad. Replaced as part of the recommendation in 2006.

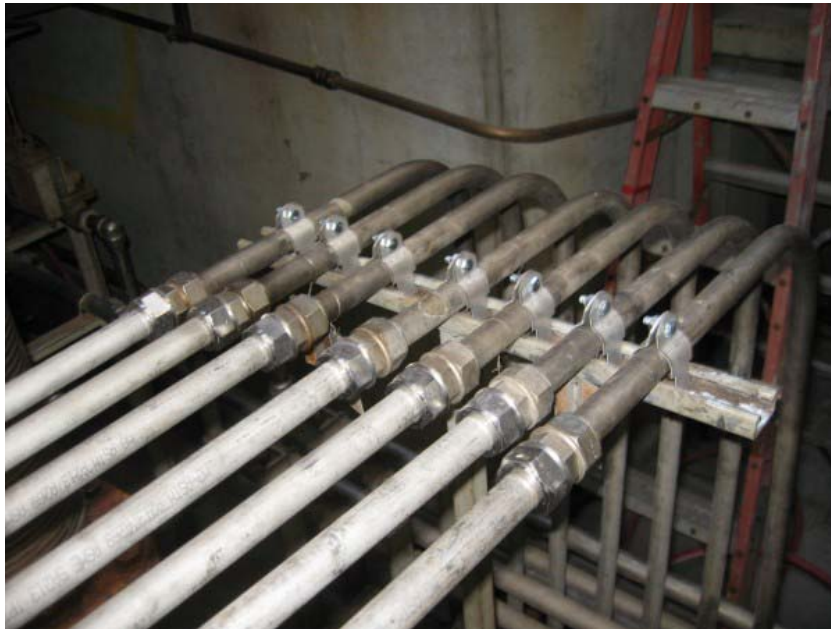
LF Tubing

During the outage, a sub-contractor (Voom) replaced all the liquid fuel and water injection tubing from the bulkheads to the combustion cans. All tubing and necessary fittings were replaced and pressure tested prior to start up. In order to complete this process, the unit was partially rebuilt to give Voom access to run all new tubing without interfering with the base piping and hardware.

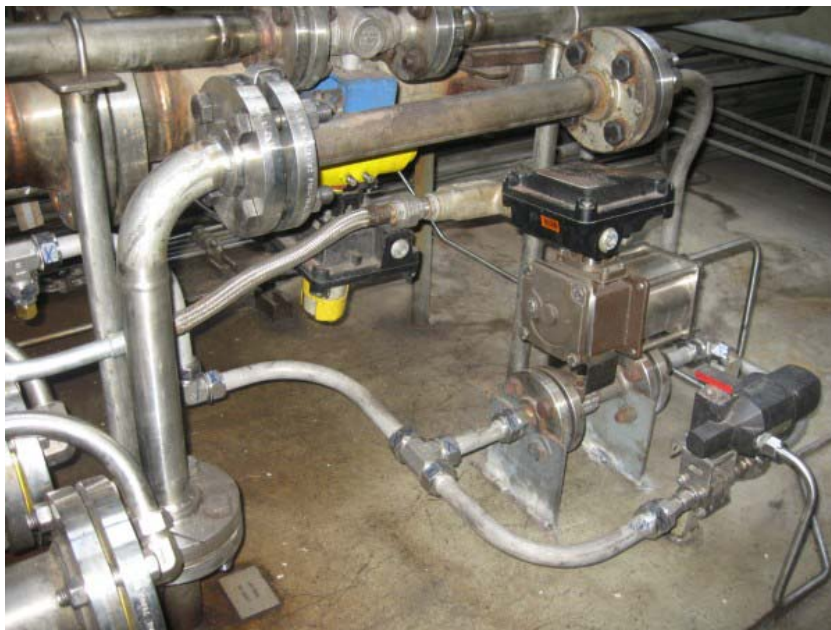
The fuel purge air system was also re-tubed during the outage. The purge valve was moved downstairs in hopes that the temperature will be cooler and the switches would last longer. This system was also pressure tested prior to start up.

Purge Valve Re Located

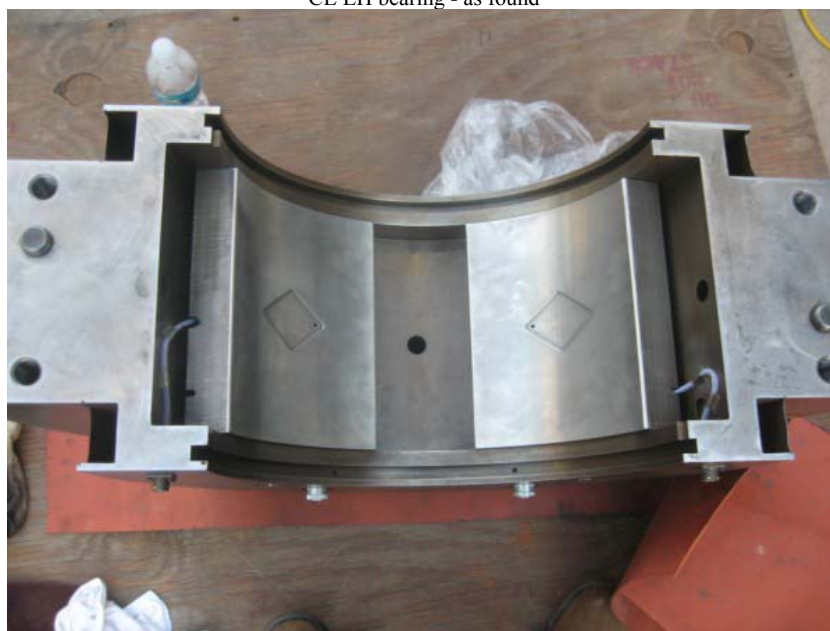
The generator bearings were removed during the outage. Each was cleaned and inspected for wear, damage, and clearance and babbitt separation. Both were found to have babbitt issues and were also missing a T/C. The bearings were shipped to a certified GE service center for repair. The bearings returned to site and were visually inspected. The bearings were reinstalled in the generator and a final pinch check was performed. All checks were within GE specification.

Generator Bearing prior to installation

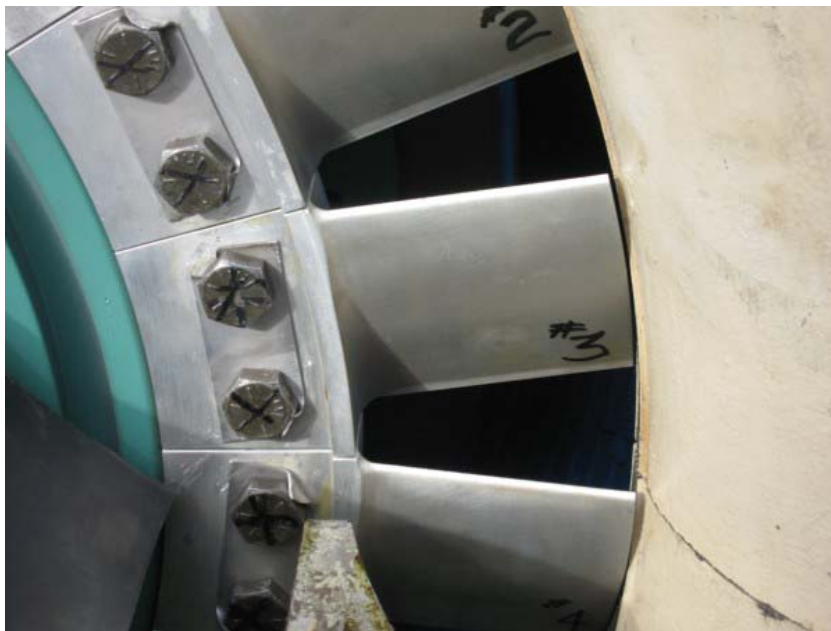
CE Fan Blades

The TE and CE fan blades were removed during the outage in order to remove the inner gas shields. Each fan blade numbered, cleaned and visually inspected for damage. No defects were found. The blades were reinstalled on the field with new lock plates and torqued.
