Power Delivery Performance

Hurricane Dorian

Storm Date: September 3, 2019

Report Date: May 8, 2020

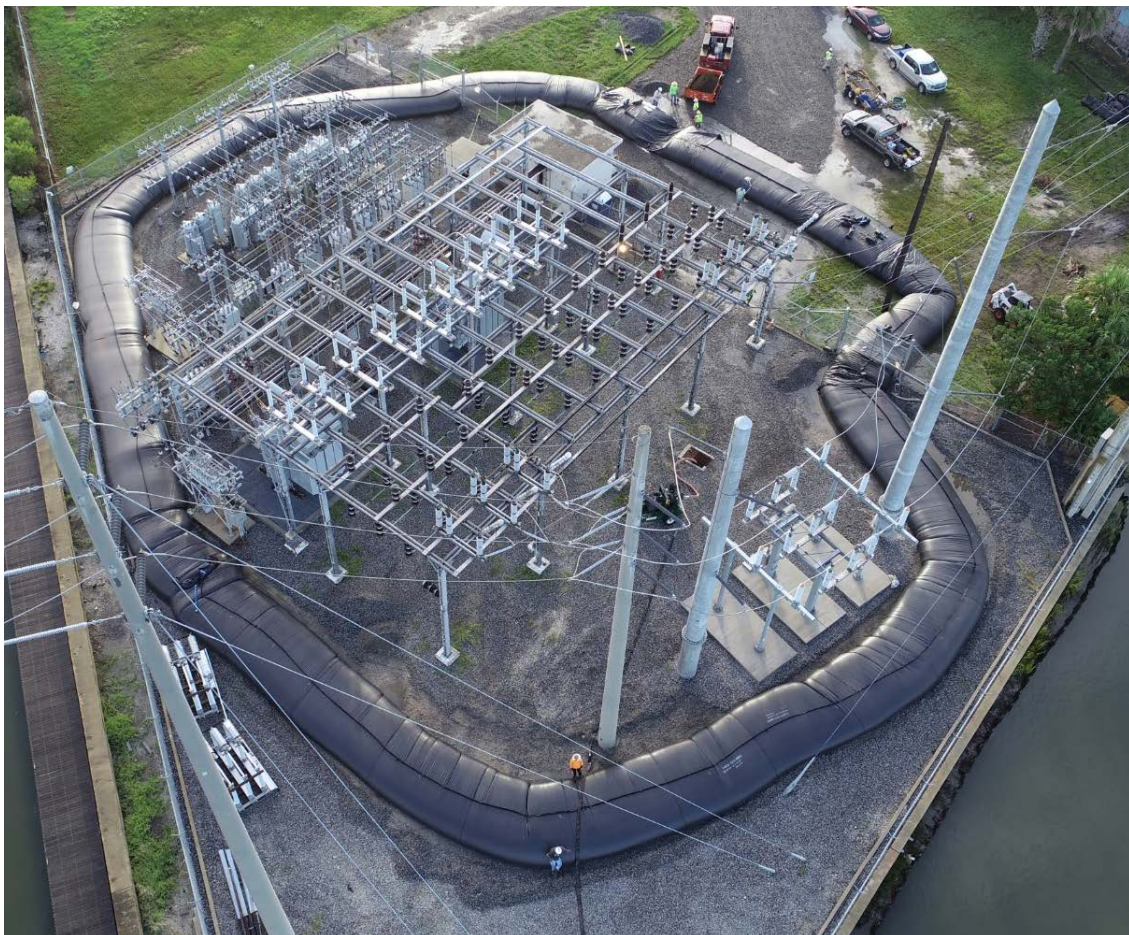
St. Augustine AquaDam Pre-Storm

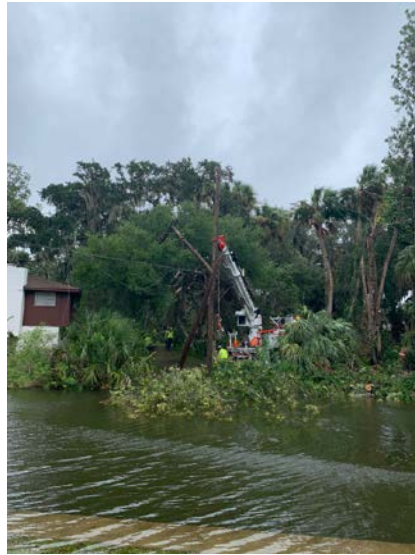
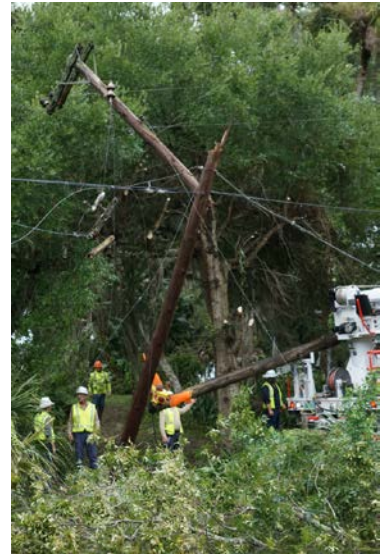
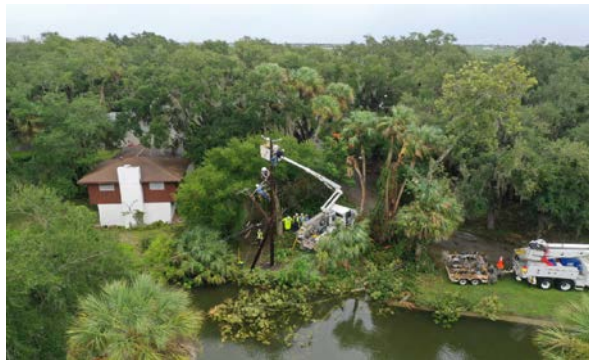
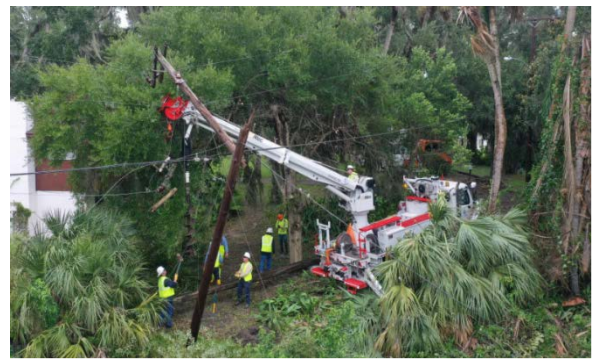
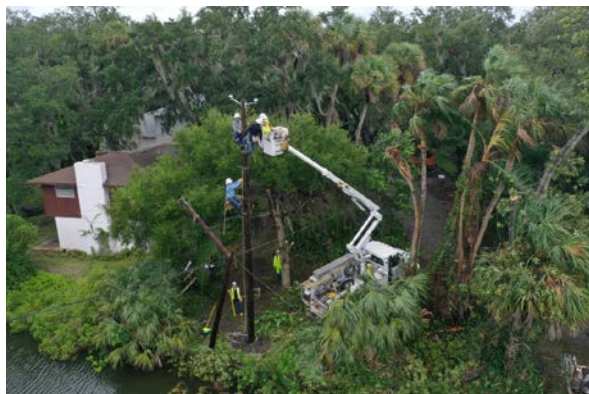
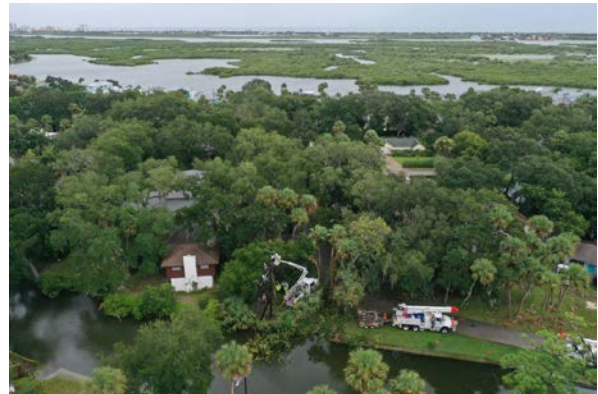
| FDR# | Sub | MA | FPL or ATT | TT# | Date | LLN#/FPL ID | Detail Comments of outage |
|---|---|---|---|---|---|---|--|
| 104832 | Taylor | CF | FPL | 255 | 9/4/2019 | ? | Tree took out lateral and broke pole. |

- FPL
- Tree / Vegetation
- TT# 255 on 9/4/19
- CF / Taylor / 104832 (Daytona)

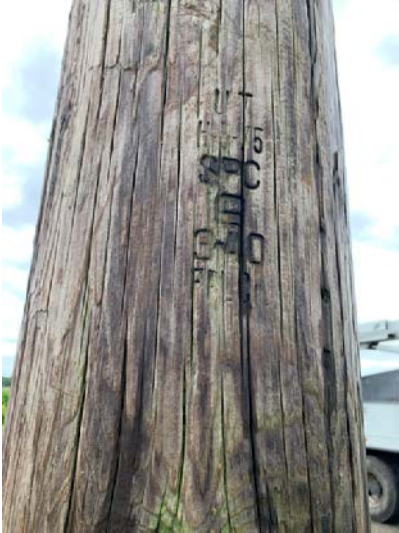
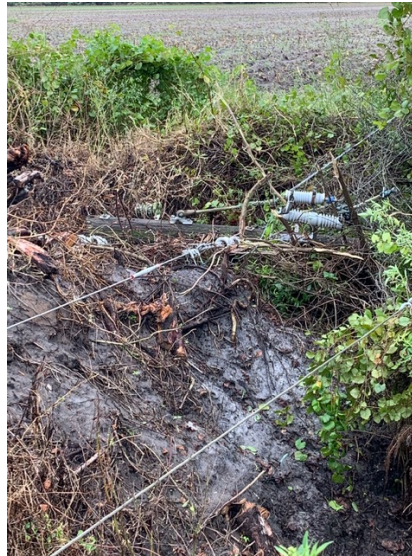
- FPL
- Tree / Vegetation
- TT# 1449
- NF / Elkton / 105832 (St. Augustine)

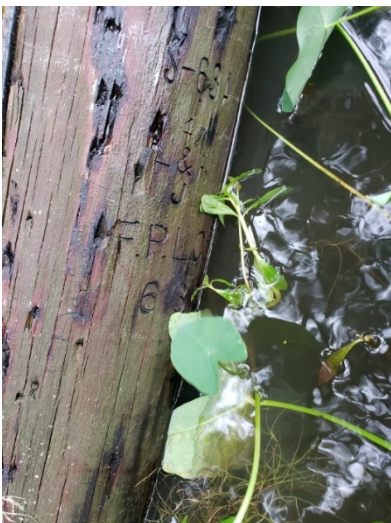
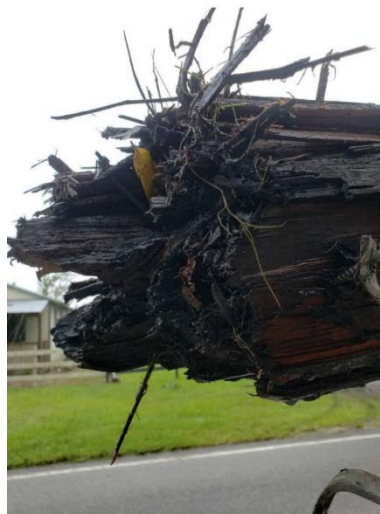
- FPL
- Tree fell on line breaking pole
- TT# 1235
- NF / Elkton / 105832 (St. Augustine)

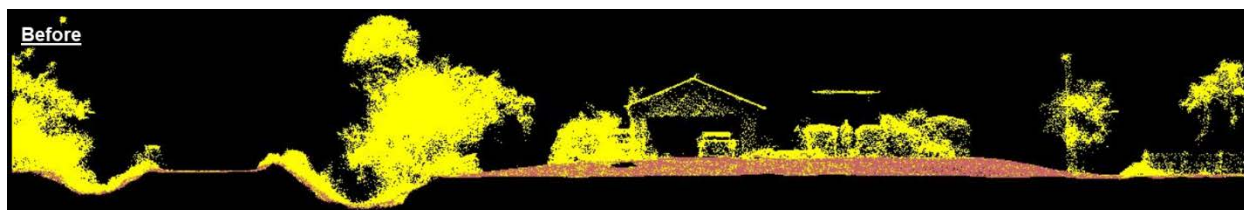
- No changes were found with broken poles or vegetation.

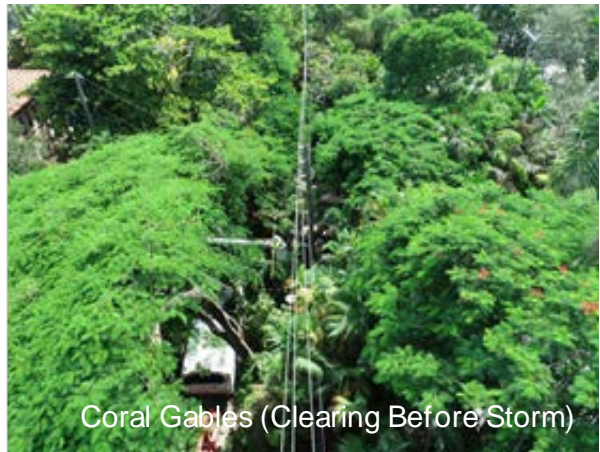
Coral Gables (Clearing Before Storm)
